# Manhole Inspection Summary

Manhole # S31II\_016MH

**Location** Address: **1501 MOSHER ST**

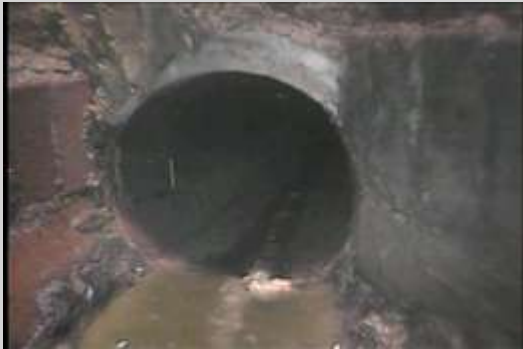
### 8 in. Circular Gravity Sewer Pipe Out @ 12 O'Clock

Rod and Bar (Angled)

Pipe Material: **Clay** ☐ Pipe Lined

Invert Depth: **9.19** (ft.) Flow Characteristics: **Slow**

Deposits: ☒ None ☐ Mud ☐ Sludge ☐ Debris ☐ Grease

Infiltration: **None** Pipe Seal Cond: **Unknown**

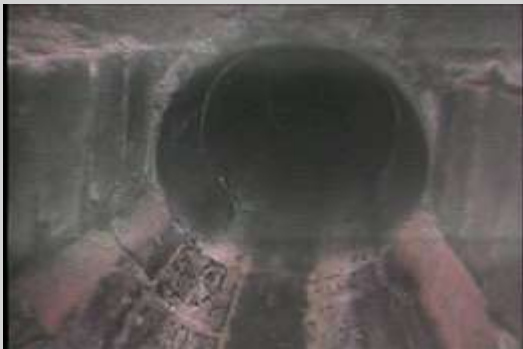
### 8 in. Circular Gravity Sewer Pipe In @ 6 O'Clock

Rod and Bar (Angled)

Pipe Material: **Clay** ☐ Pipe Lined

Infiltration: **None** Pipe Seal Cond: **Unknown**
